Vipers, Enfields and Silks

Royal Enfield Forks

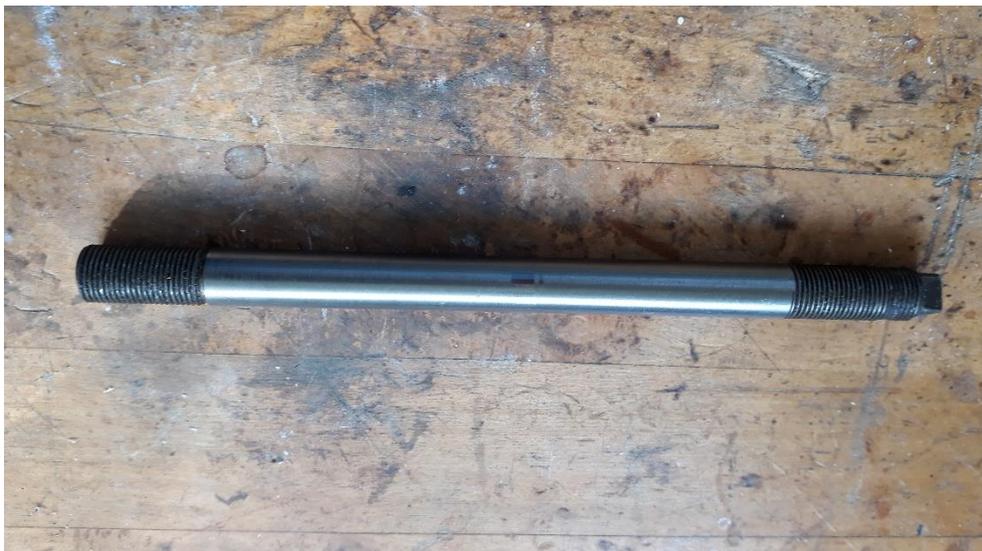
Enfield Fork Spindle

With a bit of time on hands I decided it was time to sort out the front forks on the 250cc S2 Royal Enfield. There was quite a bit of play in the top spindle on the fork girder. New spindles for the post-war 350 Enfields from Hitchcocks are very similar and can be modified to fit but because there are no bushes the new spindles didn't help with the wear in the holes. The castings are quite thin and trying to machine out and fit bushes is way beyond my capabilities and equipment. Measuring the holes showed the actual wear was about 6 thou. in the fore and aft direction making the holes oval. To make the holes round again I obtained an H2 adjustable reamer and pilot from our favourite auction site. T&J brand are high quality and worth looking for and new old stock appears at times at good prices. Using the reamer and pilot the holes trued up at 10 thou oversize. All I needed now was an oversized spindle. A tough steel is required to withstand the high shear loads on the spindle especially when hitting a pot hole. EN16 and EN24 steels seem to be the specifications commonly used for fork spindles so I obtained a length of 1/2" EN16 and set about turning a new spindle which is about 8" long. It took most of the afternoon to get my Myford lathe set up to turn the spindle to 1 thou between centres. The next problem was cutting the threads on the ends of the spindle, left and right hand 7/16" Cycle thread. I had a 7/16" Cycle right hand die so that was easy. To my surprise a tool supplier was selling off 7/16" HSS left hand Cycle thread dies on Ebay for £3. Problem solved. The spindle fitted nicely in the bore and was well greased before a test ride. Result – a big improvement in the ride over bumps. No clattering from forks and very smooth action.

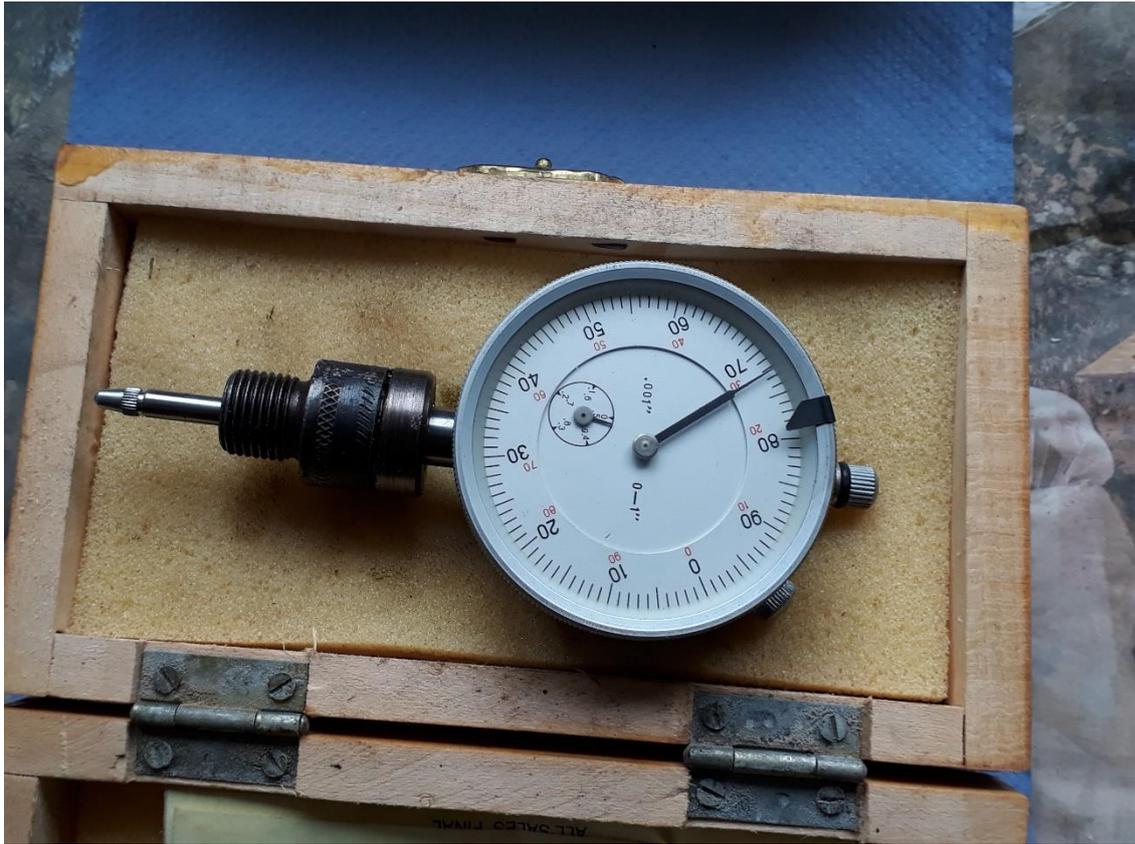
TDI with adaptor

The tool to hold the TDI was made from an old spark plug. I removed the internals and glued a bush in place with Loctite 638. While at it I made a pin so the tool could be used as a depth stop too.

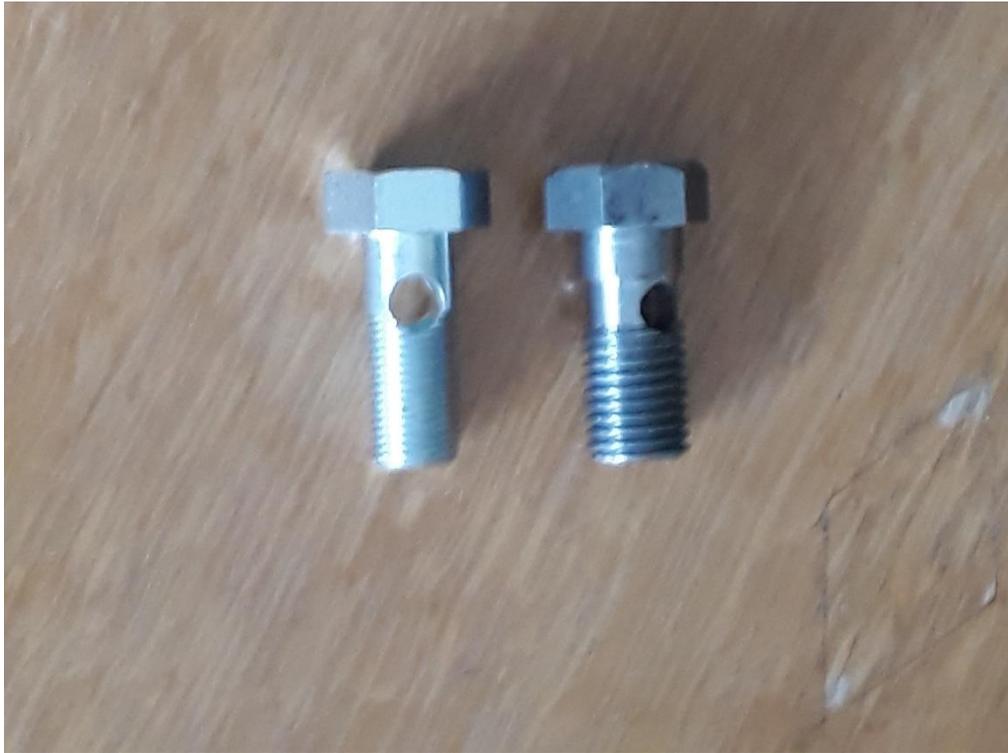
The next problem was the oil return banjo bolt had stripped its thread in the crankcase. It was quite a mess and my thoughts were now more about an EBay offering for a project Viper than yet another repair. Helicoil repair kits for 1/8 BSP are available but the hole was in such a bad state that there wouldn't be much material for the fine helicoil insert to hold in the crankcase. In the Hints and Tips, Director's Cut sent out with Fishtail there is an article on helicoiling and in it it mentions that Ralph Seymour made BSF threaded M 214 oil banjo bolts if helicoiling couldn't be done. The cleaned up hole turned out to be the exact tapping size for 7/16" BSF. I was surprised how soft the crankcase alloy is when tapping the hole, no wonder the threads strip if a heavy hand is used tightening the banjo bolts. I had purchase some Whitworth sized hexagonal bar at Kempton Park autojumble some time ago and set about making a slightly oversize banjo bolt. The bolt is a nice snug fit in the crankcase and the banjo needed to be opened out a small amount. I have had the Viper over 40 years and hopefully the repair will last for the next 40.

M 214 banjo bolt left, oversized 7/16 BSF banjo bolt right

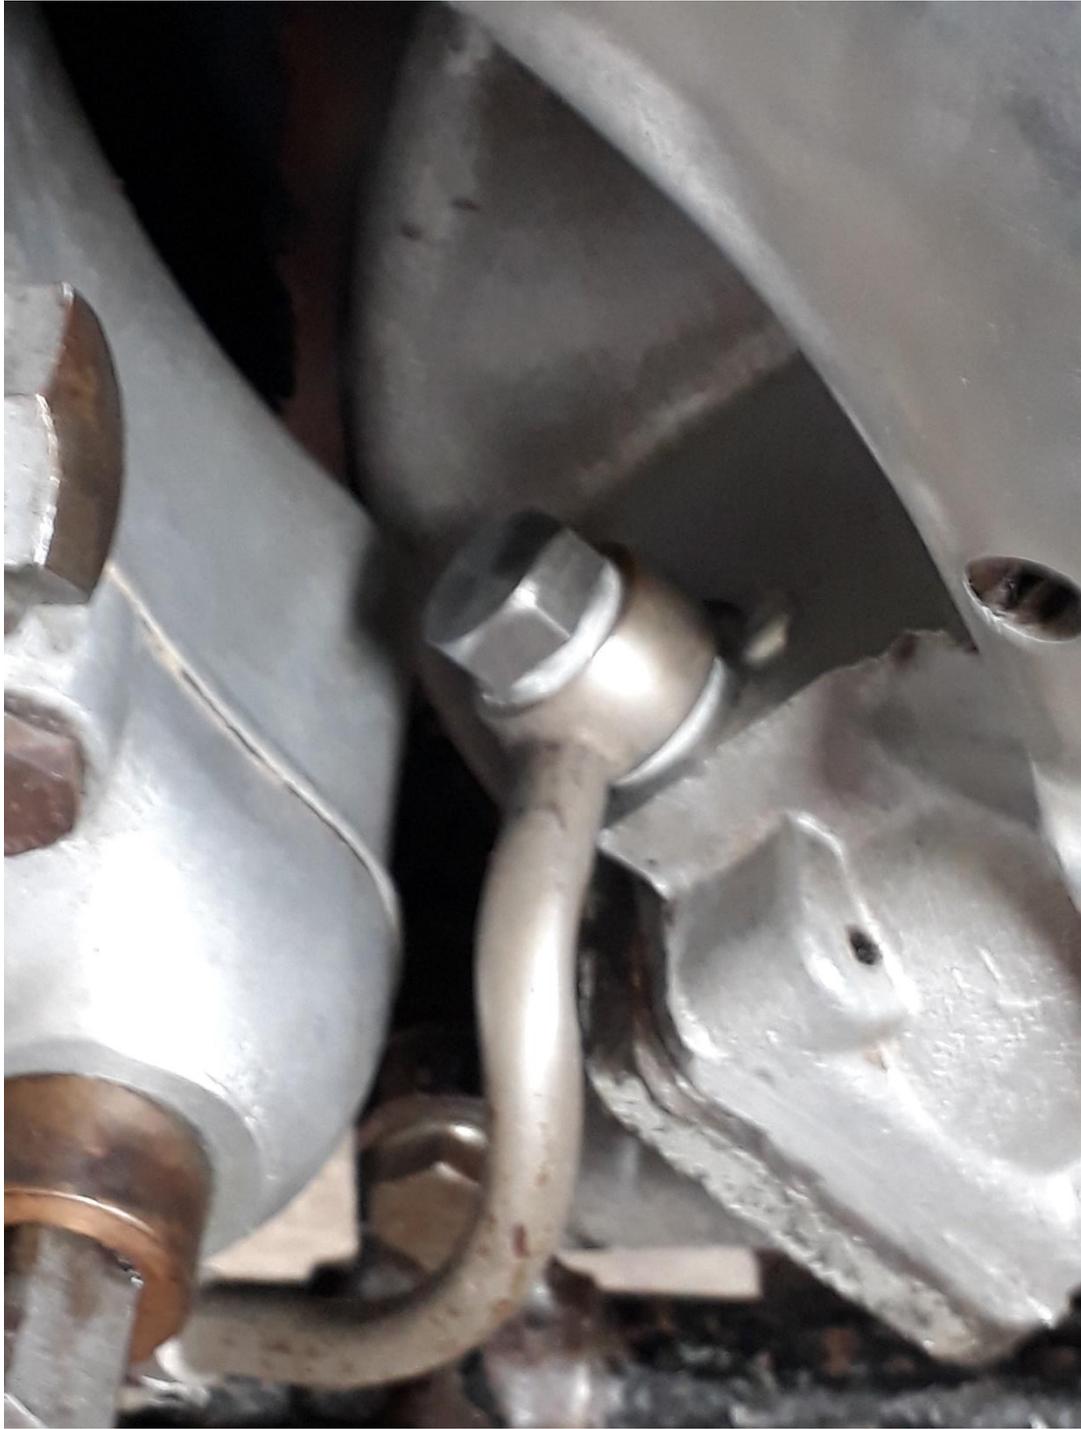
Repair completed
