It's 'D' Toolbox

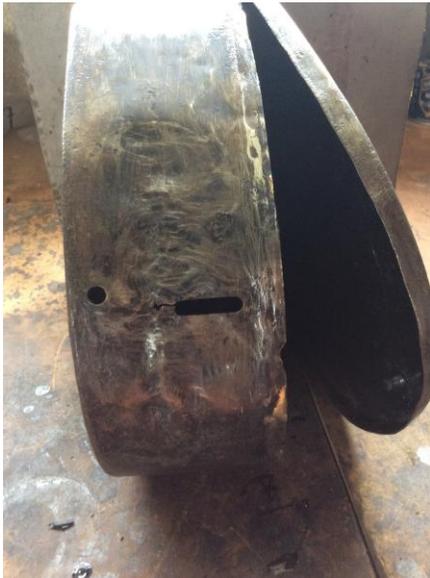
Original tool box

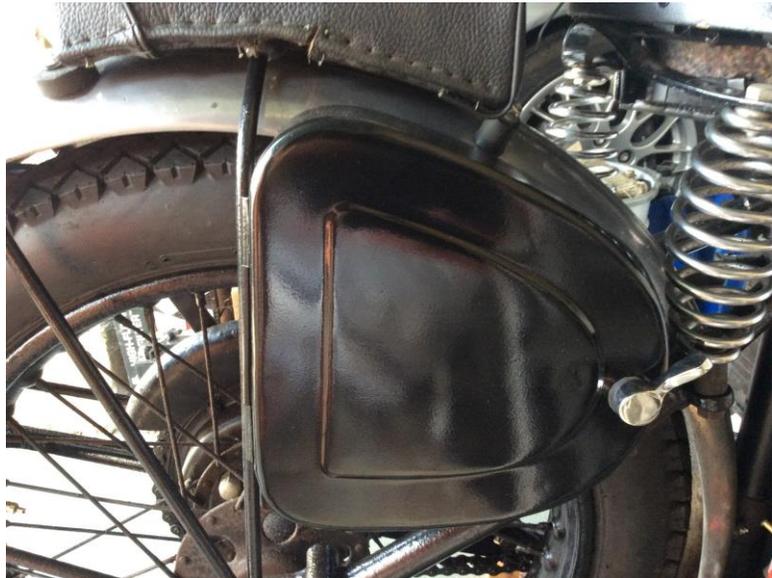
New tool box in place

The final task was to paint the toolbox which amazingly was drama free, and secure the knob that was supplied loose. I made a rubber washer out of an old bicycle inner tube to fit over the thread and sit on the outside and protect the paint. On the inside is a washer followed by an extremely tight grommet. There is just sufficient movement to guarantee good alignment of the threads.
